# ALTITUDE WIND TUNNEL DEMOLITION

# AWT

## A brief history

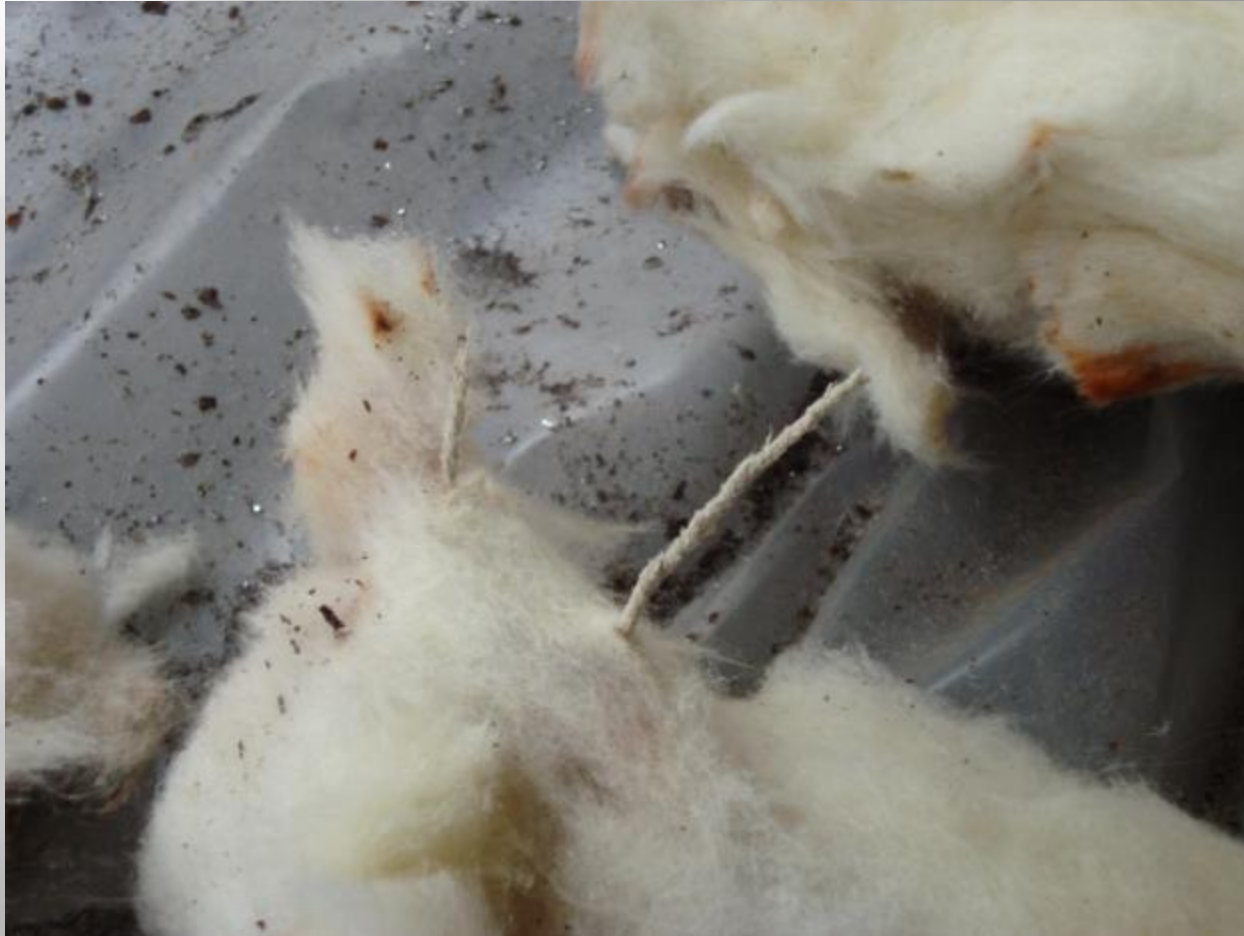
Asbestos containing rope used to attach insulation; proper protection was taken due to the material

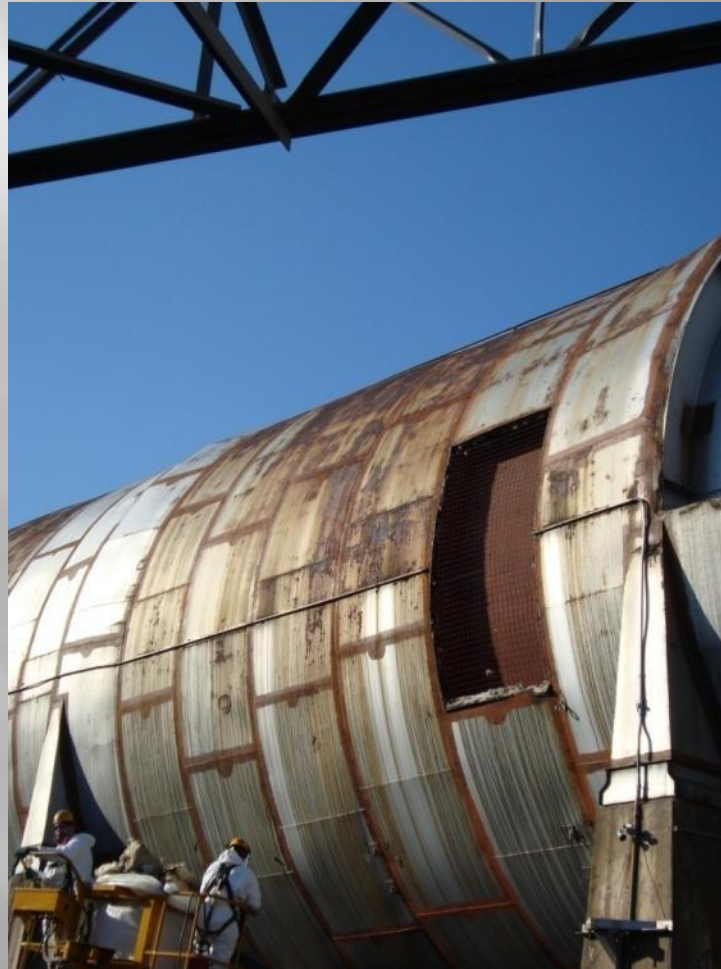
First section of outer shell and insulation removed

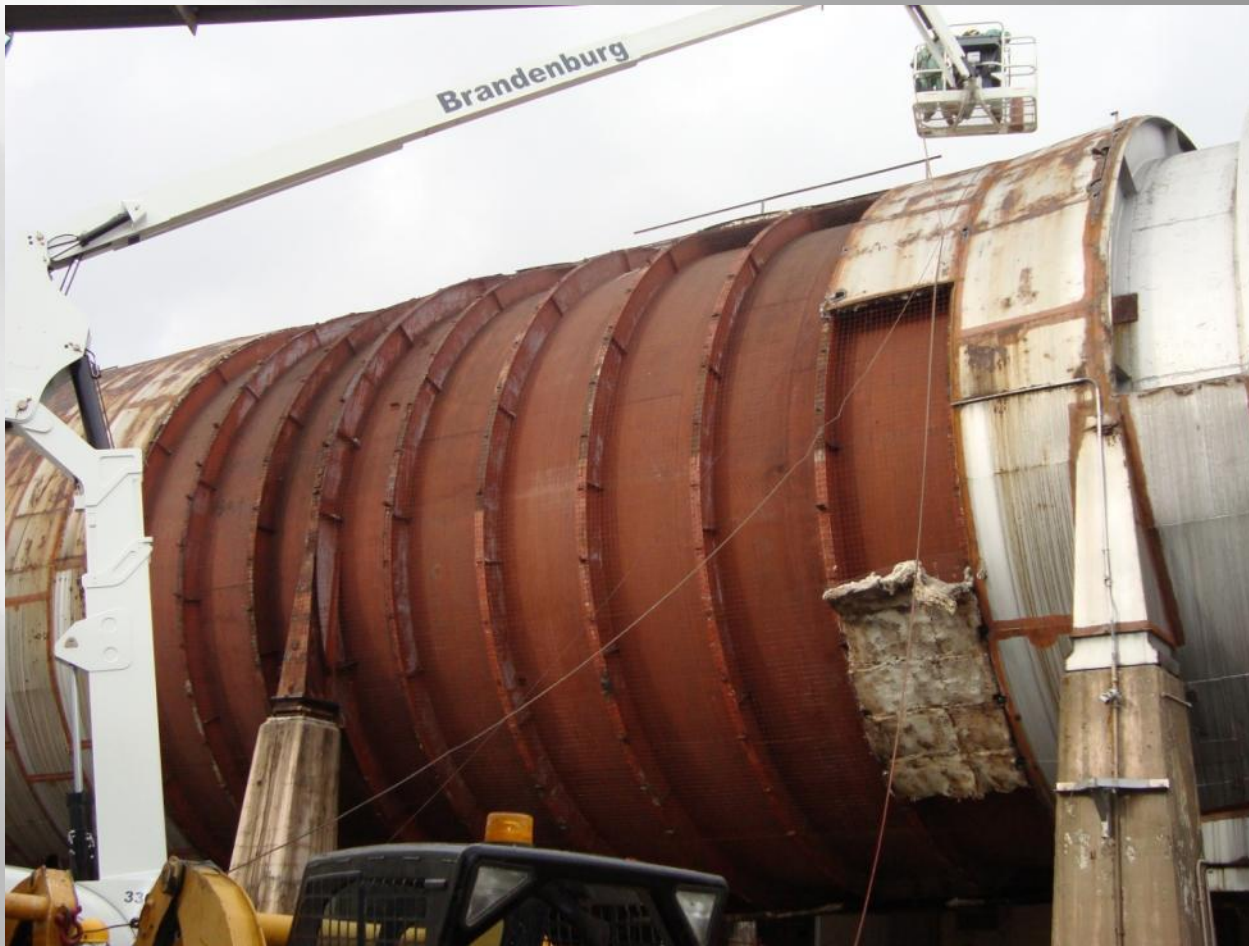
Large portion of shell and insulation removed, revealing inner shell

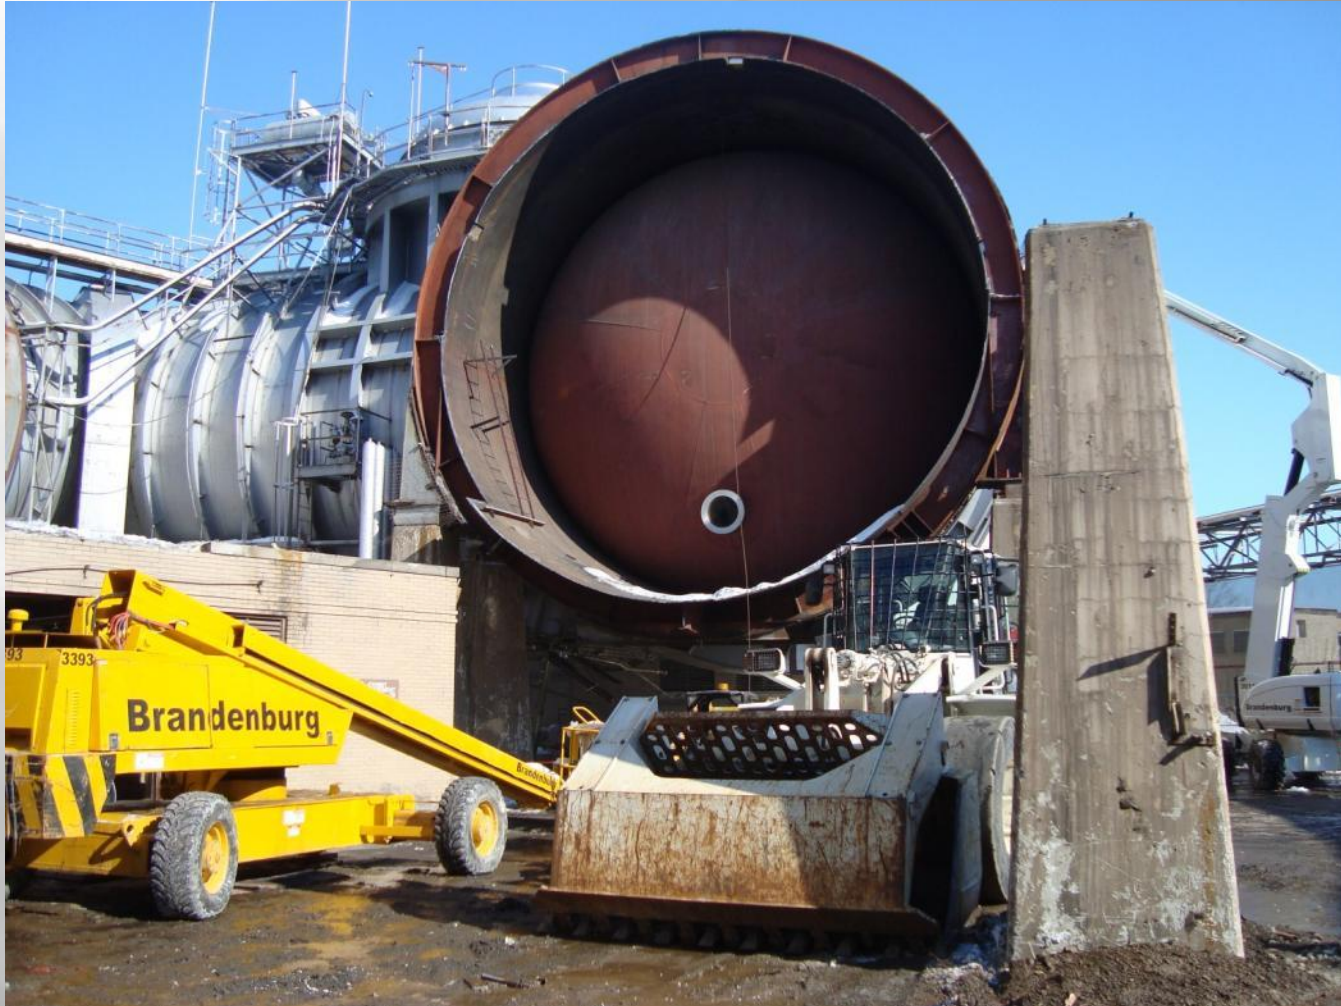
Bulkhead installed in the early 1960's converting AWT to SPC

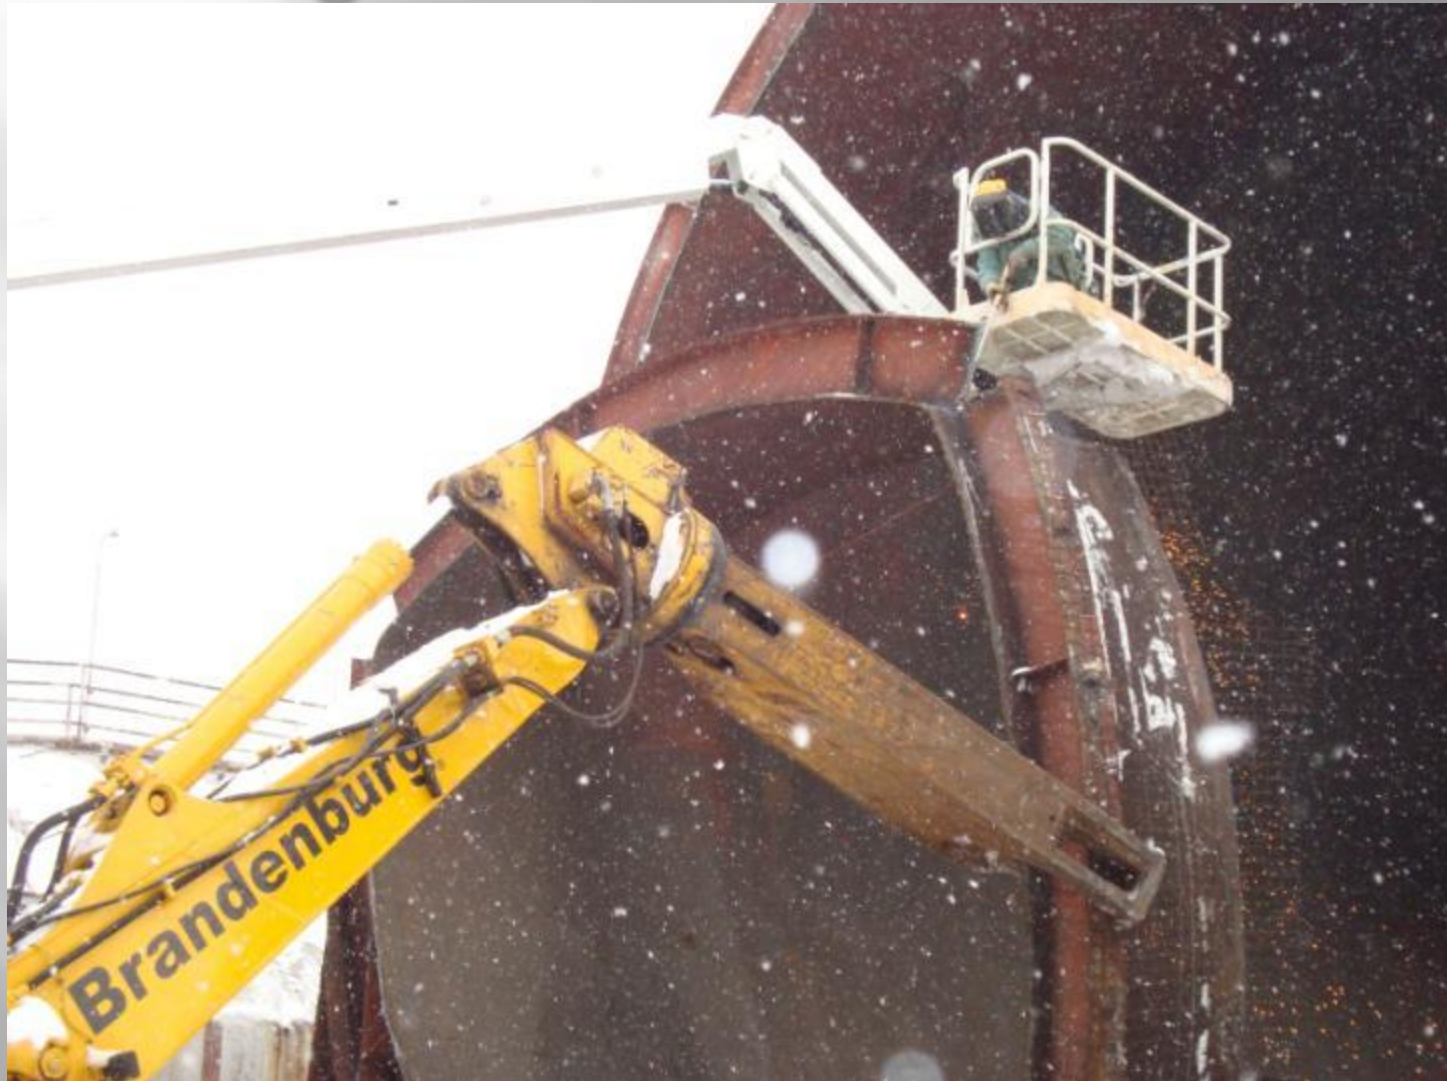
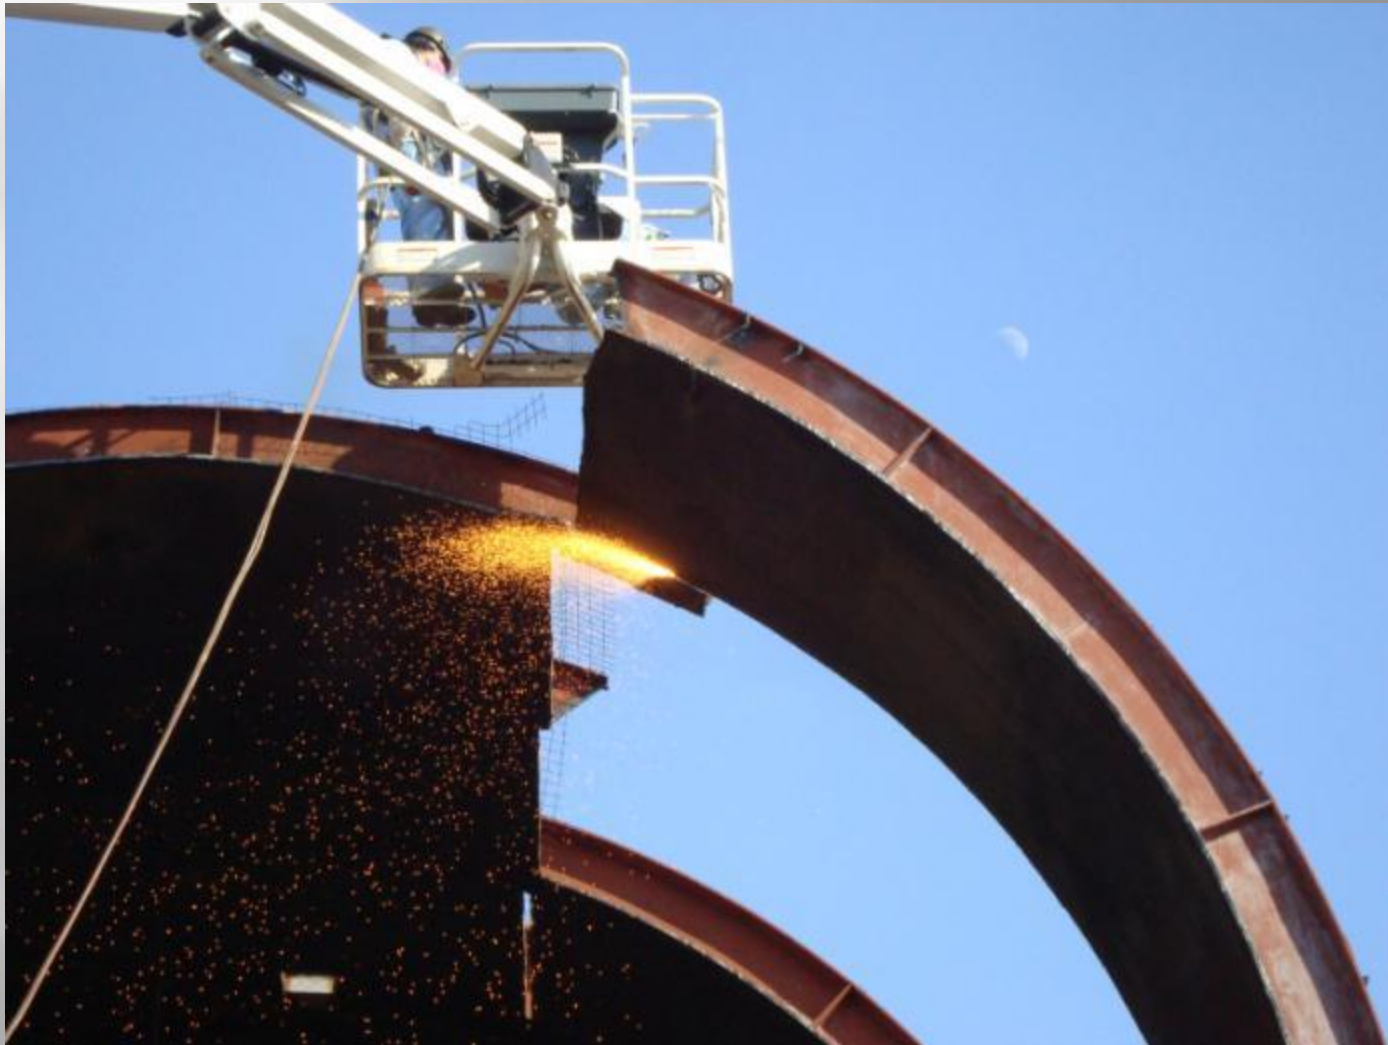
## Torching and Removal of Inner Shell

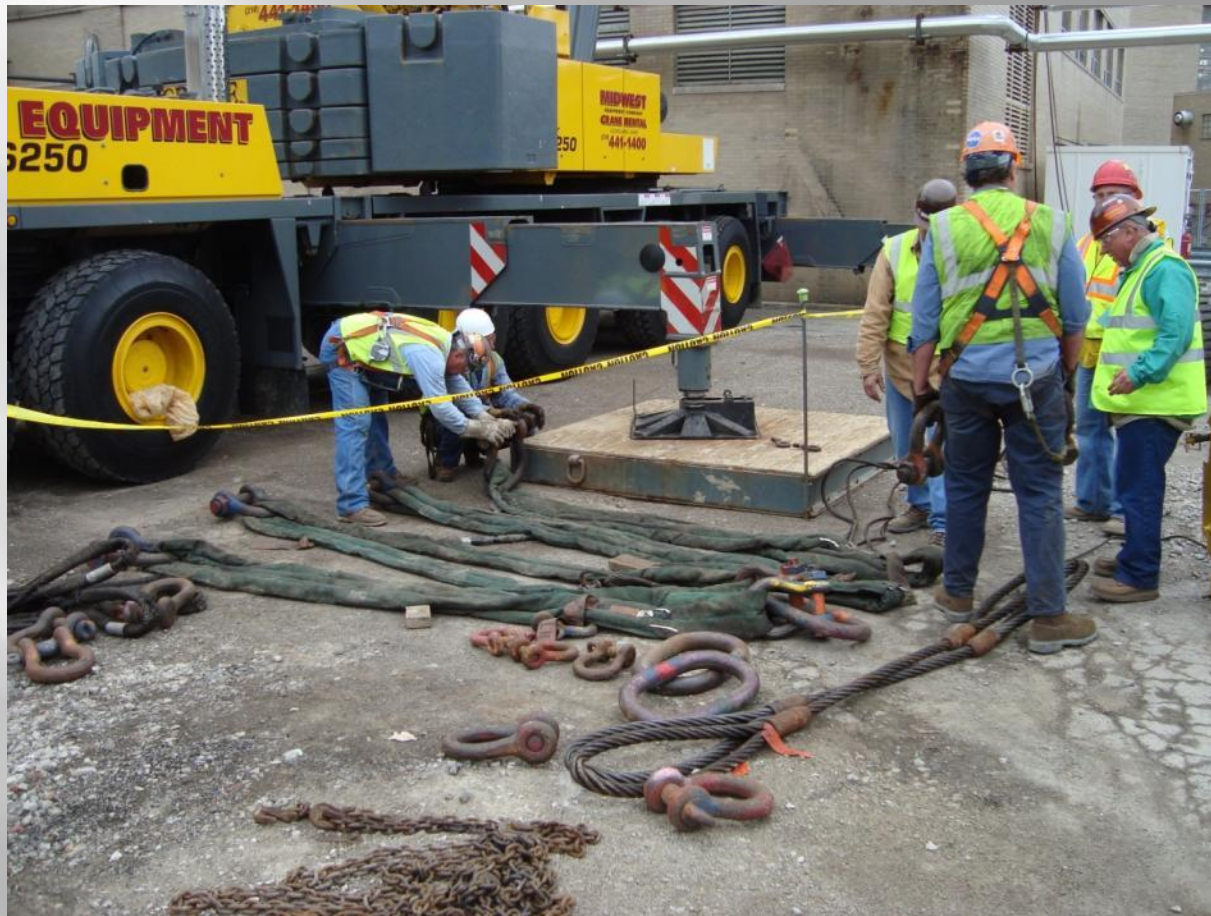
Crane mats are set beneath the crane outriggers and the rigging is prepared prior to the lift

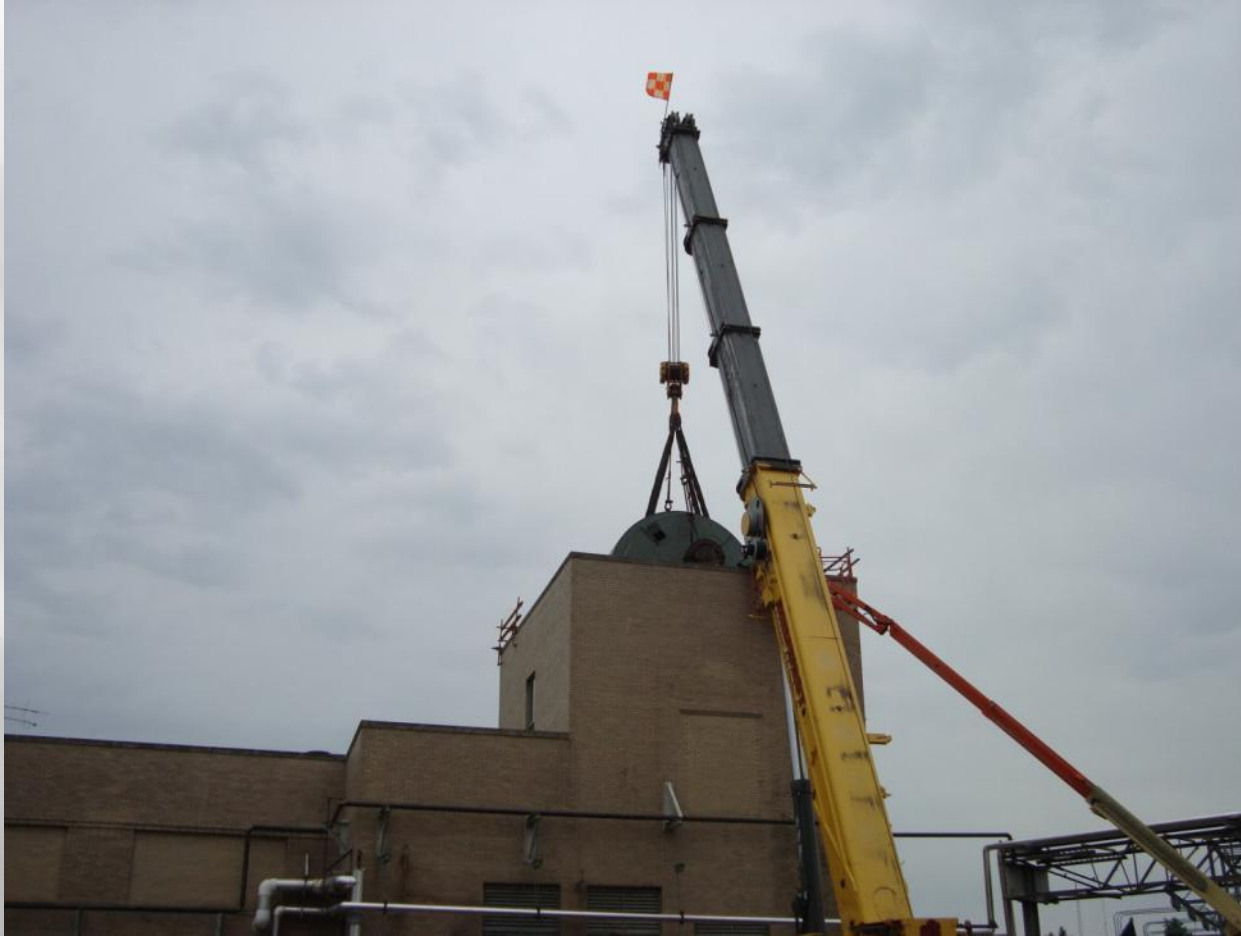
The fan drive unit is lifted through the roof of the Exhauster Building

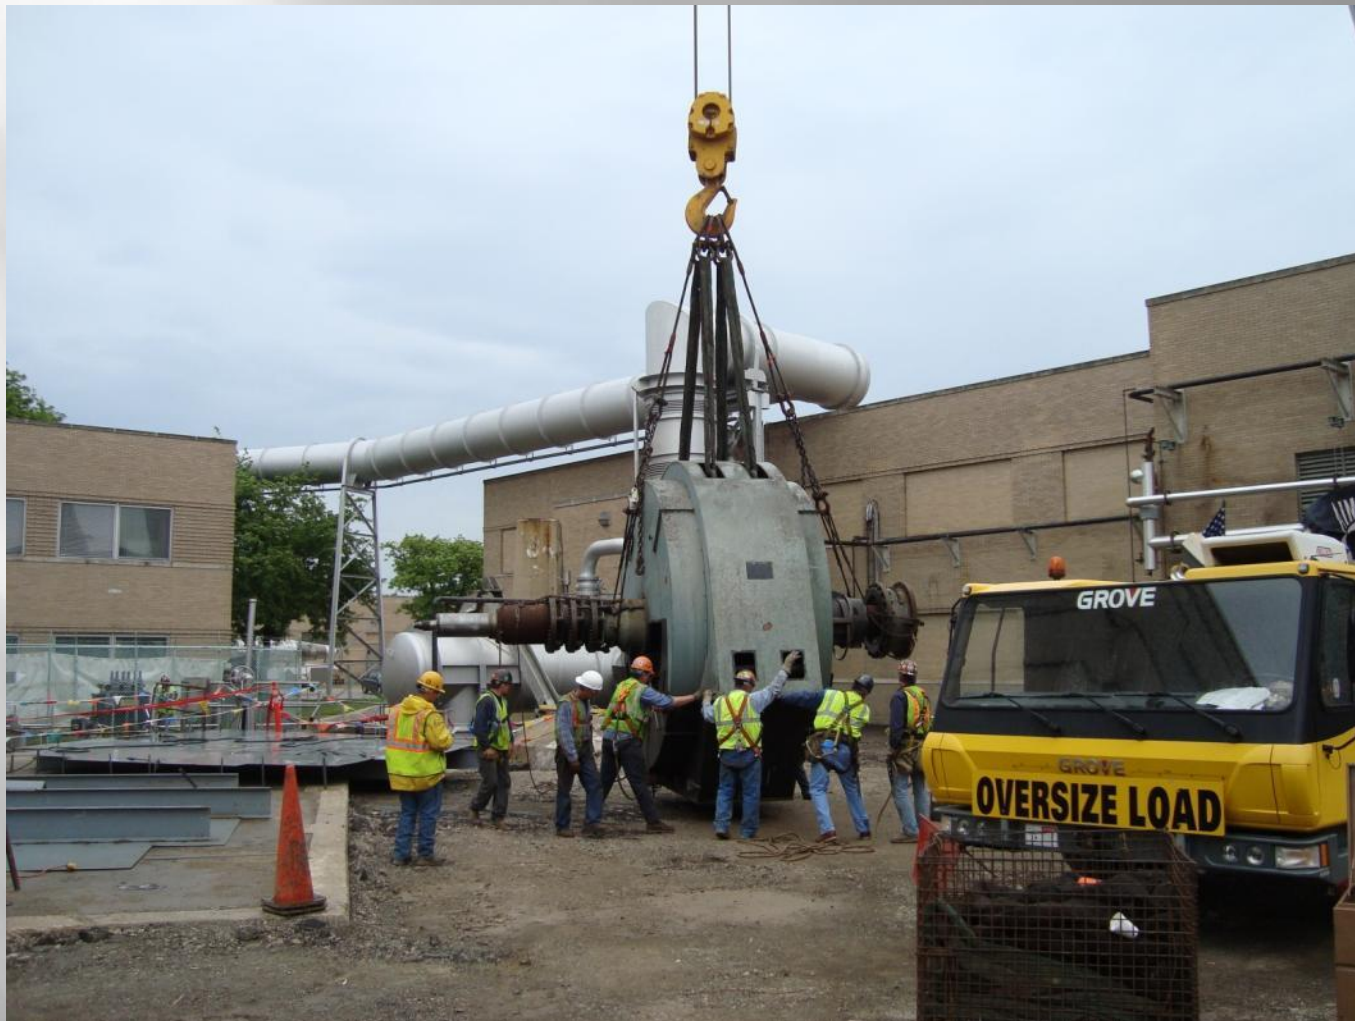
## Setting the unit

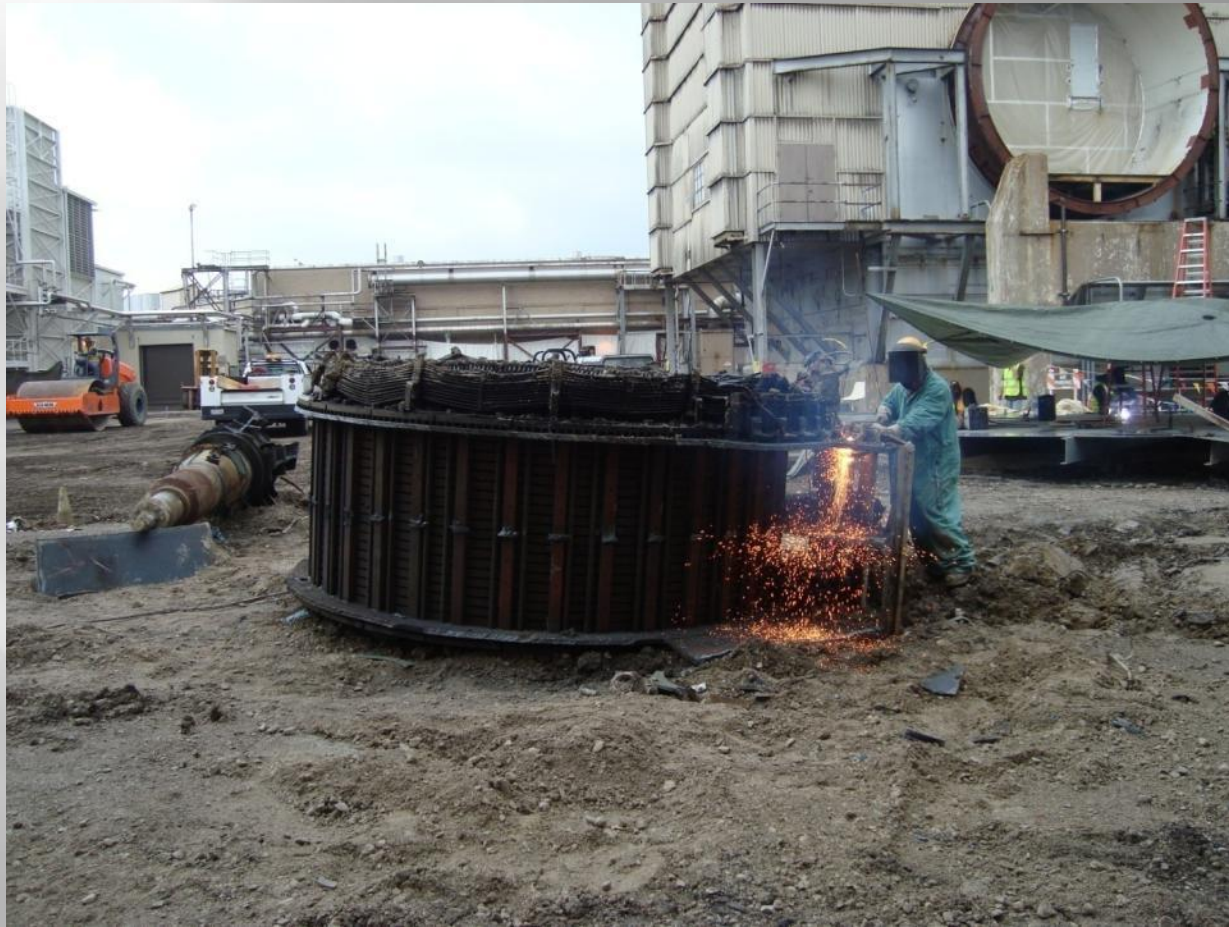
The unit is cut into manageable sections and removed from the site

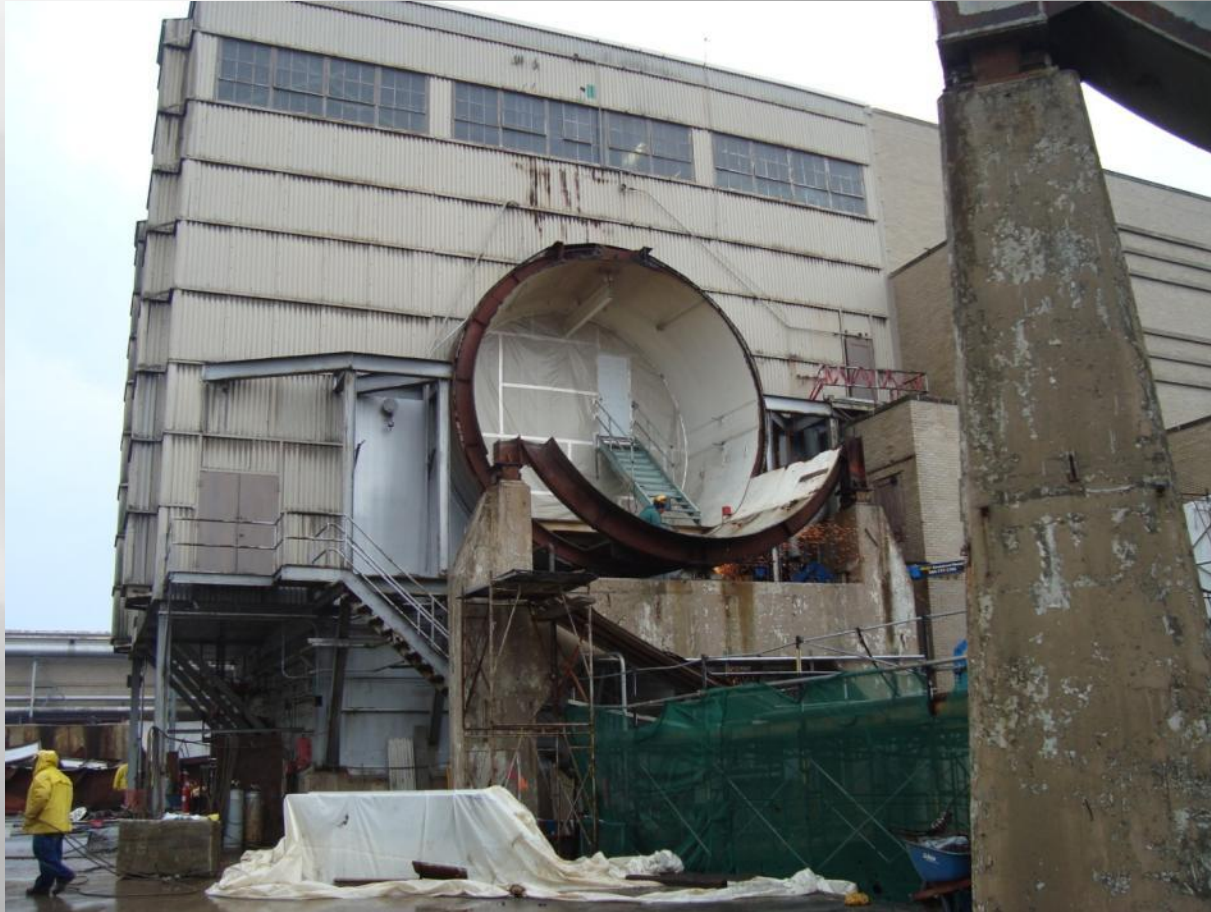
Upon completion of tunnel demo; tunnel caps were installed and painted, and asbestos containing Transite panels were removed

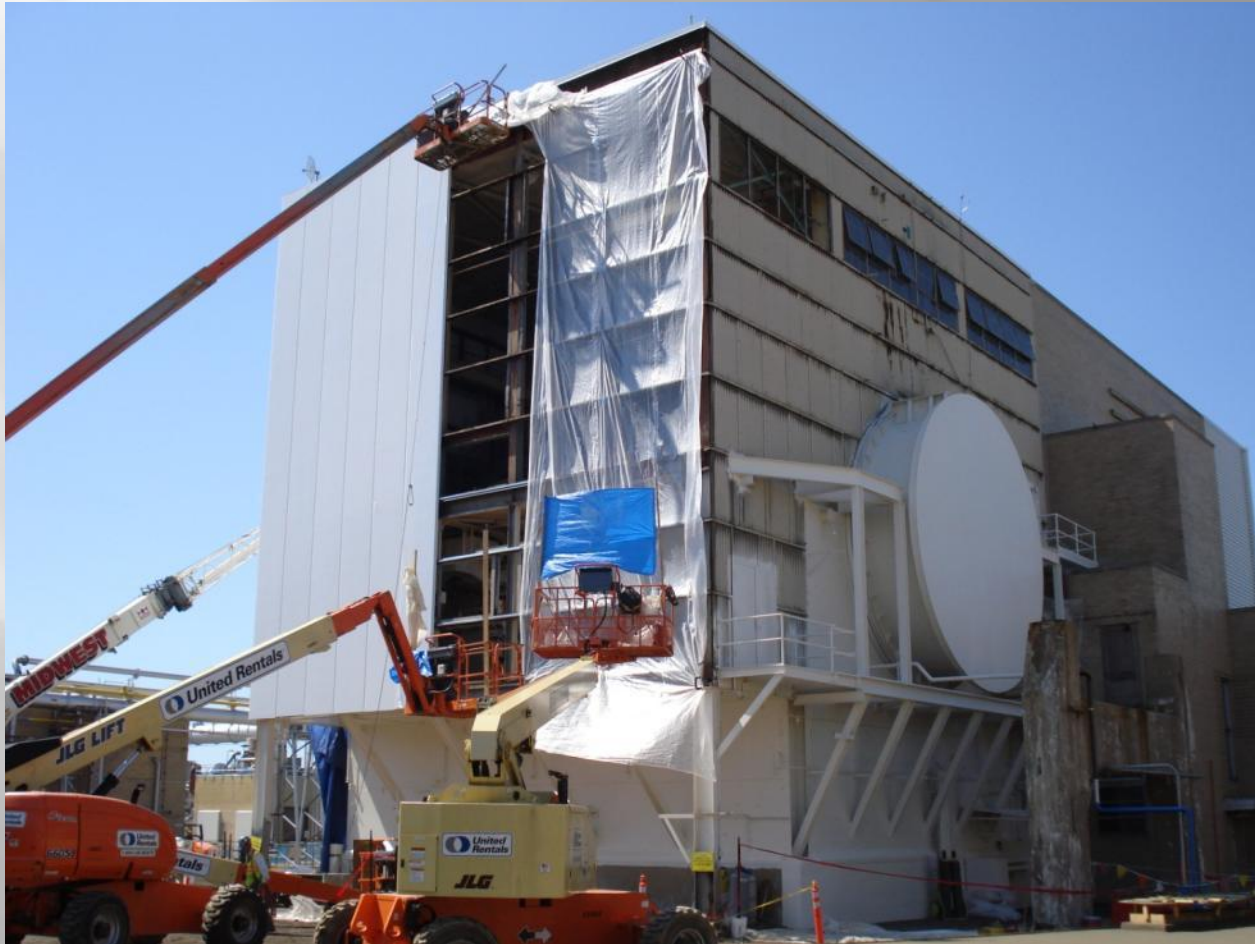
In progress; notice tunnel cap painted white, and portion of Transite panels removed with new white panels installed

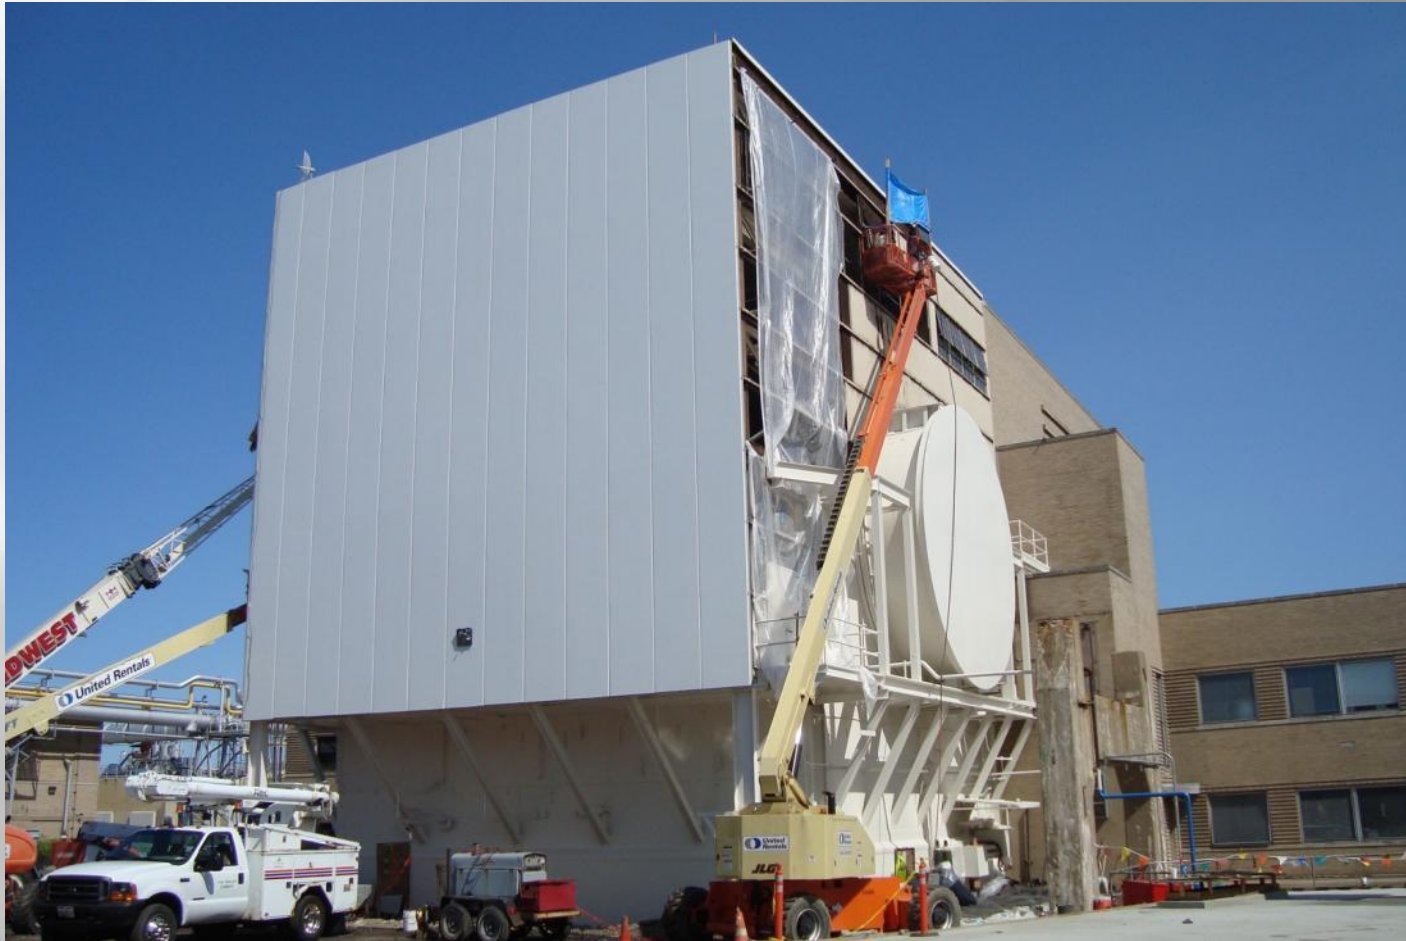
Completed south wall

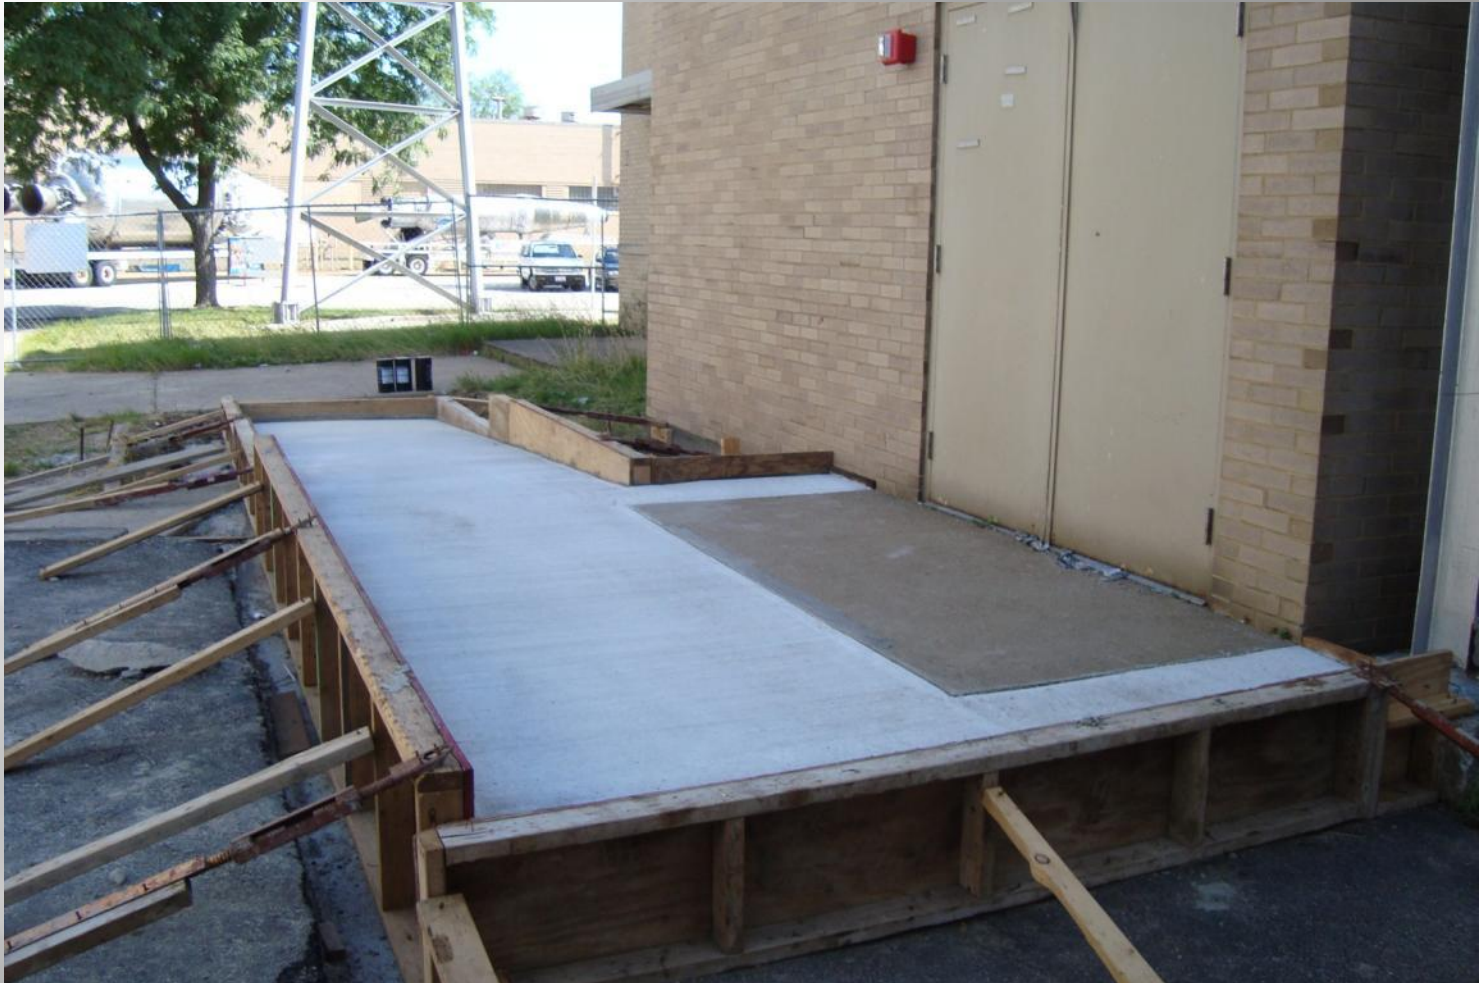
## Placement of new concrete ramp

Providing handicapped accessibility to Building 8

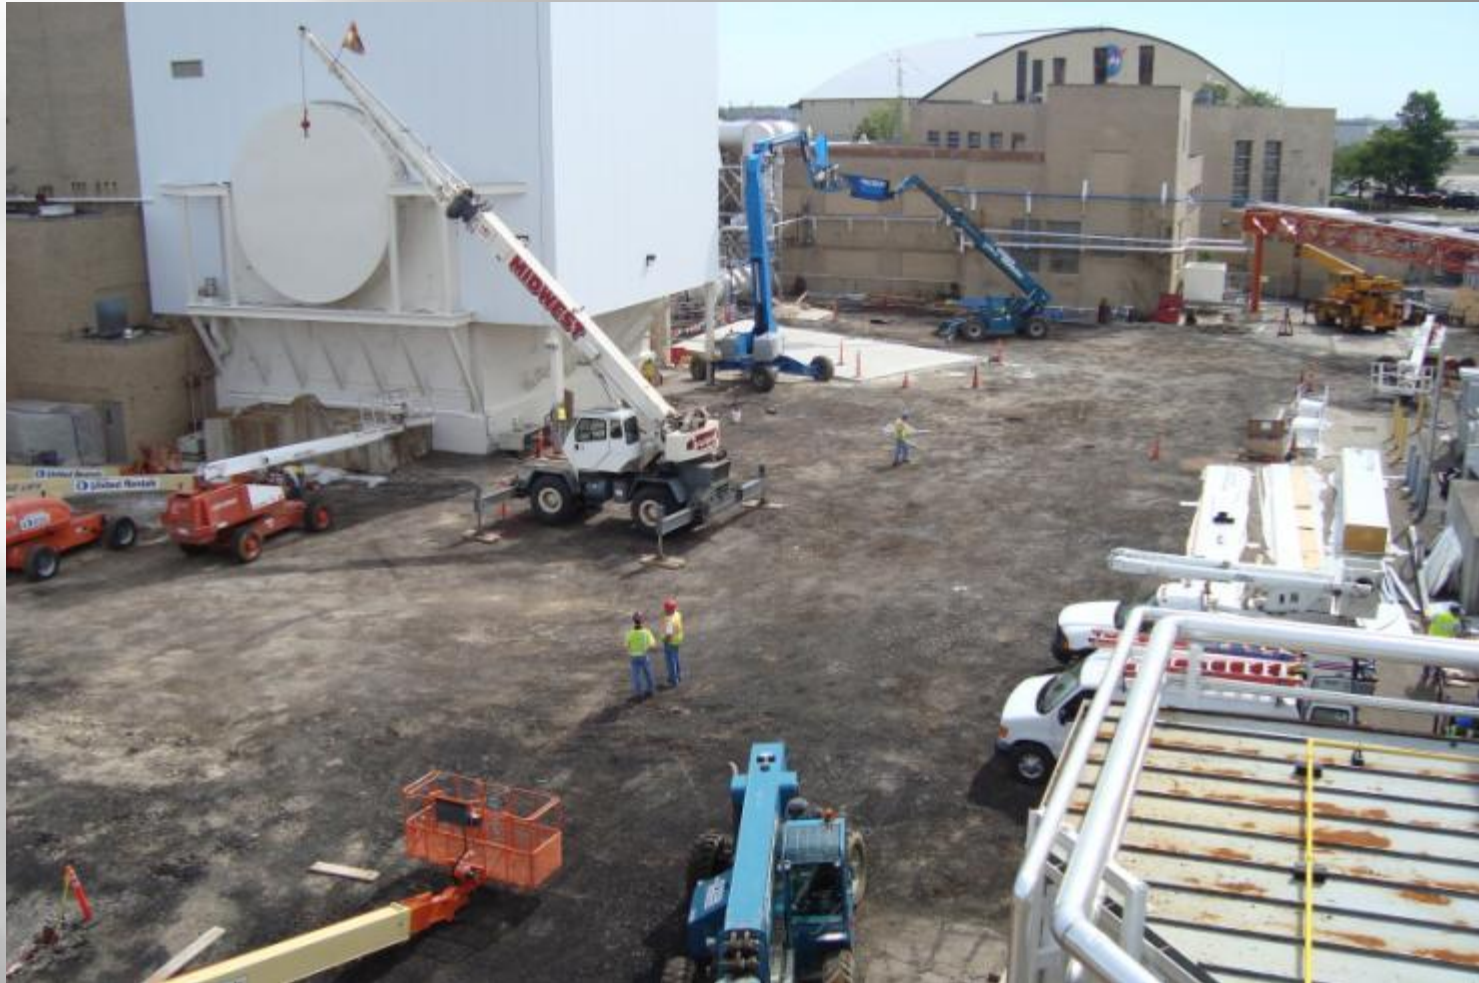
To be completed: panel installation, grading, and asphalt paving
